BorgWarner

On/Off Fan Drive Diagnostic and Service Guide

Revision 20130607

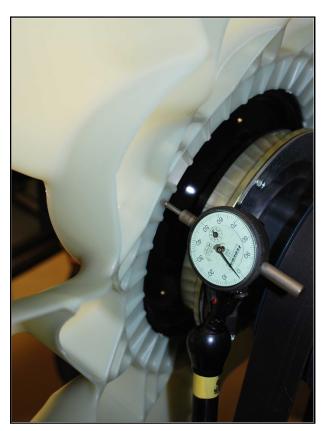
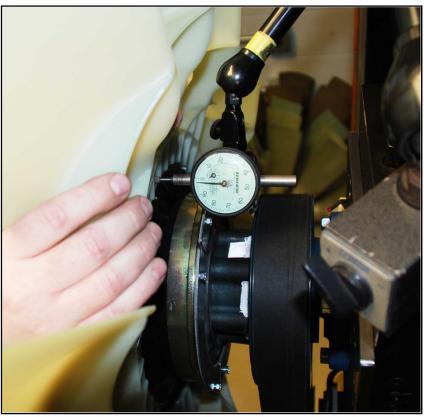
Inspecting the Clutch Assembly for Play

If the total indicator reading exceeds 0.050" (1.27mm) then the clutch should be replaced. If the total indicator reading is less than or equal to 0.050" (1.27mm) then the amount of clutch play is acceptable.

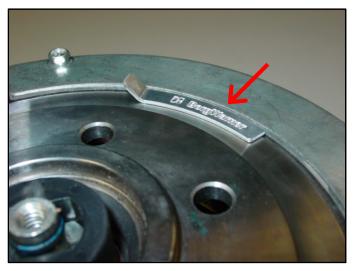
Checking the Remaining Liner Life

If the Service Alert Tool sits below the surface of the retainer plate (as shown in the image on the left) then the liner has life remaining. If the Service Alert Tool sits above the surface of the retainer plate (as shown in the image on the right) then the liner should be replaced as soon as possible. See Pg 24 to determine whether a control system issue is responsible for rapid liner wear.

Note: the Service Alert Tool has a thickness of 0.062" – if the Service Alert Tool is not available, then the liner should be replaced when the clutch shaft's rear face is less than 0.062" forward of the retainer plate's rear face.

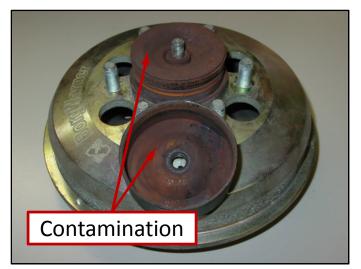
Air System Contamination

Disassembly of the clutch is not required - images are provided for reference only. Contamination in the air system may cause air seal leaks, operation troubles, or clutch failure. Any failure due to air system contamination is not warrantable through BorgWarner.

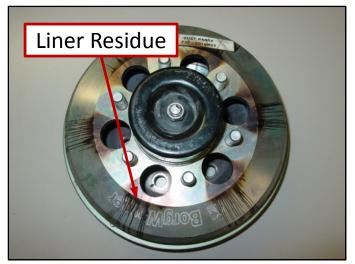
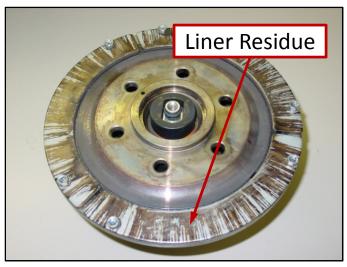
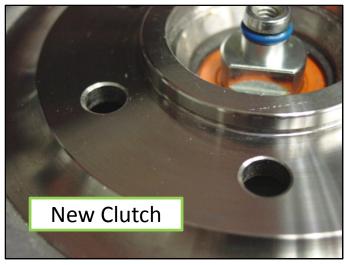
Control System Issue

A control system issue (potential root causes identified on Pg 25) or restricted fan rotation may cause the clutch to overheat and ultimately fail. Evidence of an overheated clutch includes liner residue on the forward and/or rear face of the clutch, discoloration of the rear face of the clutch, an extremely worn liner, or even a melted coupler. Any failure due to a control system issue is not warrantable through BorgWarner – check with the OEM for possible warranty coverage.

Control system issues, which may cause the clutch to wear excessively or overheat, include any of the following root causes:

- Incomplete clutch disengagement (liner still in contact) due to air pressure below 90 PSI. Verify that air pressure at the hub fitting is 90-110 PSI when the clutch is disengaged.

- Slow clutch disengagement due to a low air flow rate caused by a contaminated air solenoid, pinched air line, air leak, or high air demand.
 Verify that air pressure at the hub fitting increases almost instantaneously from 0 PSI to at least 90 PSI (in less than 1 second).

- Slow clutch disengagement or incomplete clutch disengagement due to insufficient air pressure or insufficient air flow rate ultimately caused by vehicle electrical issues. Verify that air pressure at the hub fitting increases almost instantaneously from 0 PSI to at least 90 PSI (in less than 1 second).

- Slow clutch engagement due to a plugged air vent, a contaminated air solenoid, or a pinched air line (air pressure must be released quickly to engage clutch with minimal slippage). Verify that air pressure at the hub fitting decreases almost instantaneously from more than 90 PSI down to 0 PSI (in less than 1 second).

- Frequent clutch (and fan) engagements lasting less than 30 seconds (clutch over-cycling) due to the lack of a fan "on-time" timer within the engine or vehicle control module, A/C problems, or defective control system.

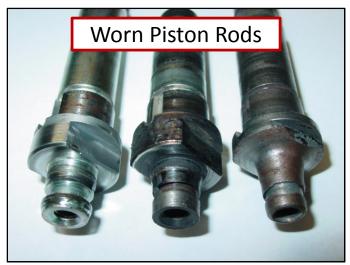
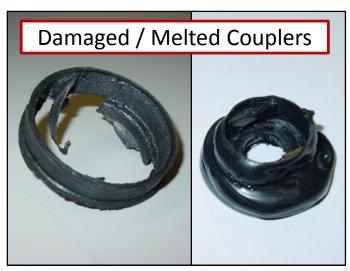
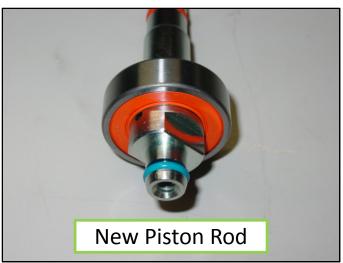
Indications of Pulley Bearing (Hub) Problems

Damage to the base of the piston rod or o-ring; a rounded out or melted coupler may be caused by pulley bearing problems. Inspect for play or rough motion in the pulley bearings (See Pg 15). If a clutch is damaged by pulley bearing problems, and the hub is still under warranty, then both the clutch and hub must be returned to BorgWarner for warranty consideration.

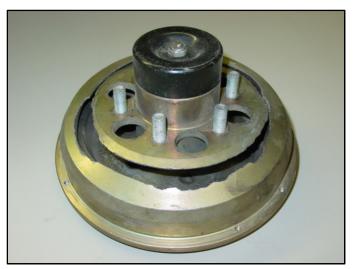
Improper Installation

Any extra bolts left loose inside the clutch housing will cause internal damage during clutch operation. Any of the 6 clutch mounting bolts that are not torqued to 45 lbf-ft (61 Nm) may become loose inside the clutch housing and cause internal damage. Bolts that are properly torqued will leave a witness mark in the clutch shaft. A failure due to improper installation is not warrantable through BorgWarner, unless the failure occurred on an original equipment factory installation.

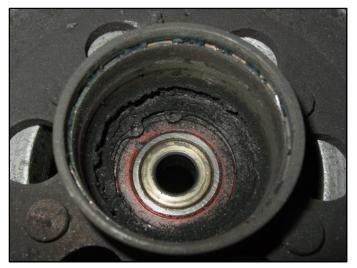
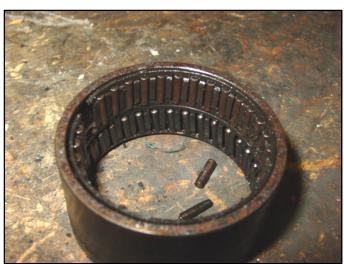
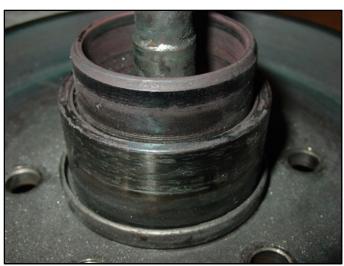
Needle Bearing Failure

Disassembly of the clutch is not required - images are provided for reference only. Needle bearing problems are rare, but can occur. If a needle bearing fails due to a hub failure (see Pg 26), and the hub is still under warranty, then both the clutch and hub must be returned for warranty consideration. If a needle bearing fails without a hub failure, then the clutch alone may be returned for warranty consideration. A needle bearing failure due to a defect in material or workmanship is warrantable through BorgWarner.

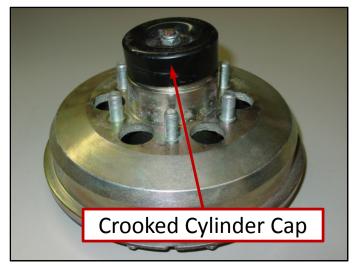
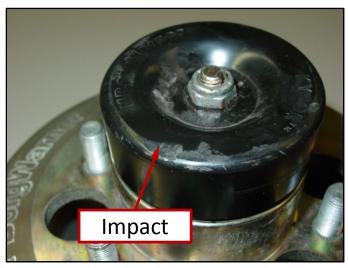
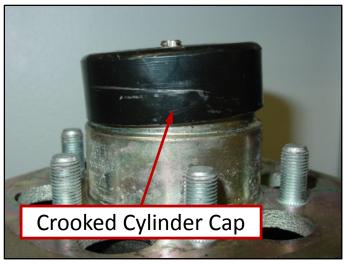
Physical Damage

An impact to the cylinder cap may bend the piston rod (which carries the cylinder cap) and produce an air seal leak. The bent piston rod may even prevent the clutch from engaging or disengaging. An impact to the clutch housing, especially near a fastener hole, may fracture the housing and cause a fastener to become loose or lost. A failure due to physical damage of any kind is not warrantable through BorgWarner.
